CASE STUDY

REPAIR AND REBUILD EFFLUENT COLUMN PUMPS

ARGO INTERNATIONAL AND FLOWSERVE

Pulp and paper mill main effluent/waste water pit pumps

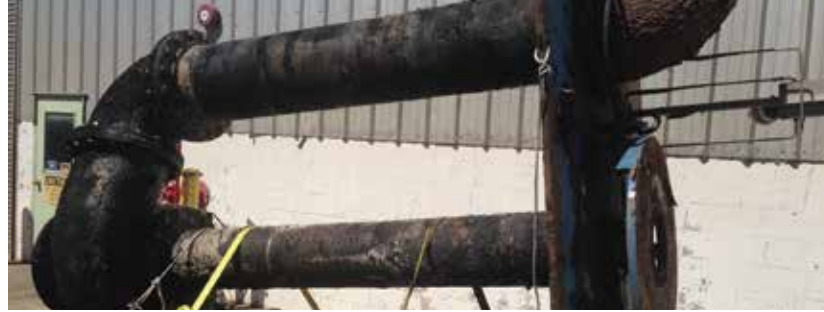
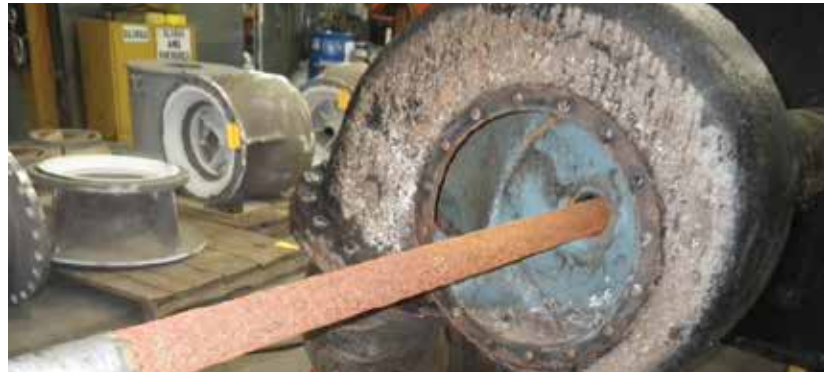
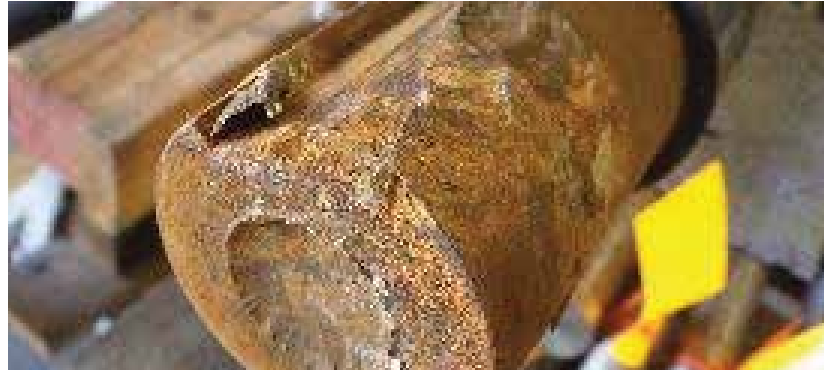
The 69-year-old Effluent Column Pumps operate in extremely challenging service conditions, and over the years, have experienced significant damage and multiple failures at the bearings, sleeves, wear surfaces and shafts, and issues included cavitation, vibration, high radial loads, cyclic loading, corrosion and erosion, ultimately leading to costly repeated downtime.

*Right - Effluent water pump as received from the paper mill.
Bottom - Effluent water pump after rebuilt and upgrade.*

Argo International's team of experts, along with Flowserve's Quick Response Repair Center, formulated a solution to upgrade most materials for these pumps including non-metallic shaft bearings, high strength shaft material, thru-hardened wear rings, optimized impeller trim and a general realignment of all register fits for this large column pump.
